Site No. 10

CARR POINT

Portsmouth Burma Road

Site Description

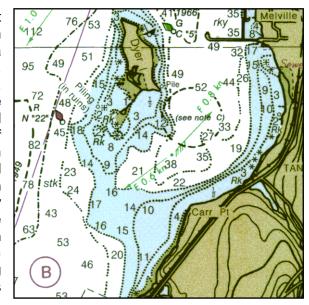
Bay Location. Situated in the upper East Passage of Narragansett Bay across from Prudence Island, Carr Point is characterized by a rocky coast and outstanding scenic character. Depths along the shoreline are relatively shallow, and one angler was observed surf fishing at the time of visit. From the Online Recreational Fishing Survey, common catch in the vicinity of the site consists of Striped Bass and Bluefish (spring - fall), with Tautog and Scup also reported in lesser numbers during the summer. Waters in the vicinity of this site were assessed as fully meeting aquatic life support criteria. waters are open to shellfishing and have been assigned a water quality goal of SA (high quality) by the RIDEM (see Appendix B). A "swimming and shellfishing prohibited, water polluted" sign is posted near the camping area (see Photo 8),

though according to park visitors this sign is quite outdated.

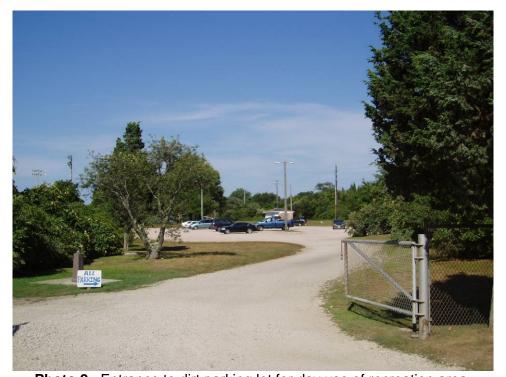
Photo 2. Entrance to dirt parking lot for day use of recreation area.

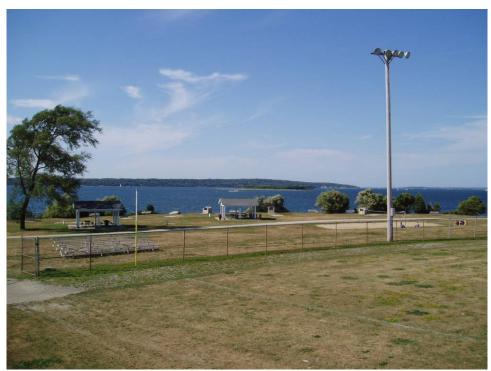
Photo 3. Carr Point Recreation Area facilities and shoreline looking northwest from softball bleachers.

As evident by the photographs provided, the Carr Point Recreation Area currently offers outstanding general recreation facilities. Though the site does not have any fishing-specific features or amenities, the natural shoreline can be directly accessed from the picnic areas (see Photos 3, 4) via a short embankment separating the beach from upland recreation facilities. The one angler present at the time of visit noted the quality of fishing and the natural, secluded character as primary reasons for frequenting the site. While this upland/beach transition is readily negotiable by foot, the embankment and the cobble beach itself likely prohibit handicap usability of the site for fishing. Interior facilities are clean and well-maintained, however a moderate amount of washed up debris and litter was observed along the length of the shoreline at this location.

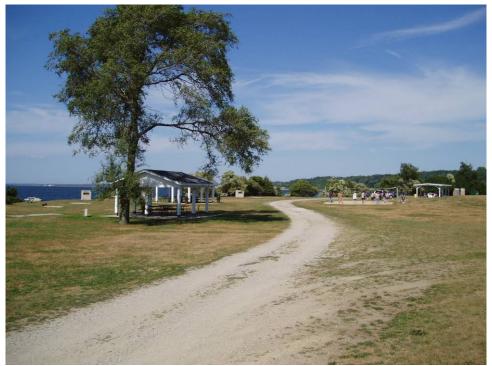
Photo 4. Recreational facilities including picnic shelters, barbecue pits, and a volleyball court.

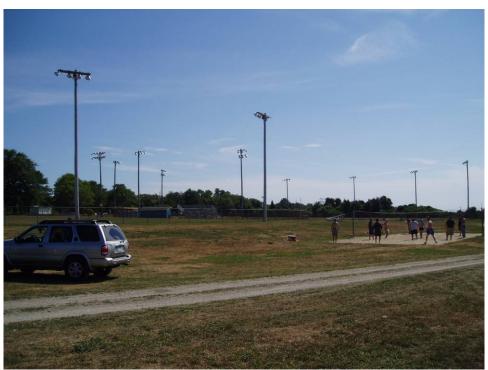
Photo 5. Interior recreation facilities looking south from near shoreline.

Landside, camping facilities occupy at the southerly half of the site near the Burma Road entrance, while facilities for active recreation (picnic areas, softball fields, volleyball court) are situated to the north of the site near Carr Point proper. A separate gravel parking lot for the active recreation facilities area (Photo 2) provides good capacity (60+ vehicles); cars were also observed parking directly at the picnic areas (Photo 5) as well.

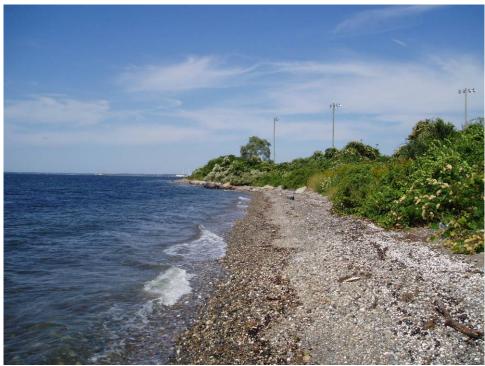
Photo 6. Carr Point shoreline looking north to Carr Point proper. Lights for the softball field are visible on the right.

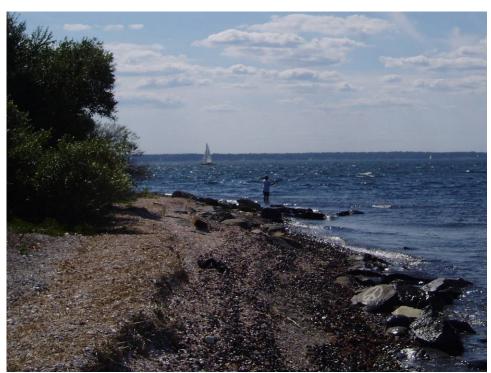
Photo 7. Fishing along cobble beach at Carr Point proper looking west.

Environmental Constraints and Permitting. Coastal features at Carr Point consist of the cobble beach and the embankment between the beach and the upland recreation area (see Photo 7). The upland edge is mowed to within approximately 6 feet of the embankment. Coastal waters at this location are classified by the CRMC as Type 4 (Multipurpose) waters, and there is the possibility that areas of eelgrass are in the vicinity.

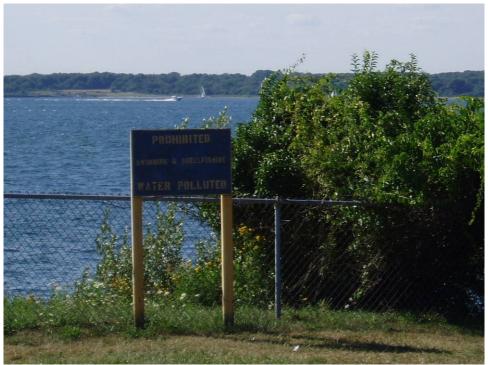
Photo 8. "Swimming and shellfishing prohibited" sign near camping area. Though this sign was posted long ago and may no longer be accurate, it still serves to dissuade visitors from fishing at the site.
